APOLLO 14 MISSION

CIRCUIT BREAKER ANOMALY

ANOMALY REPORT NO. 4

Mission Evaluation Team

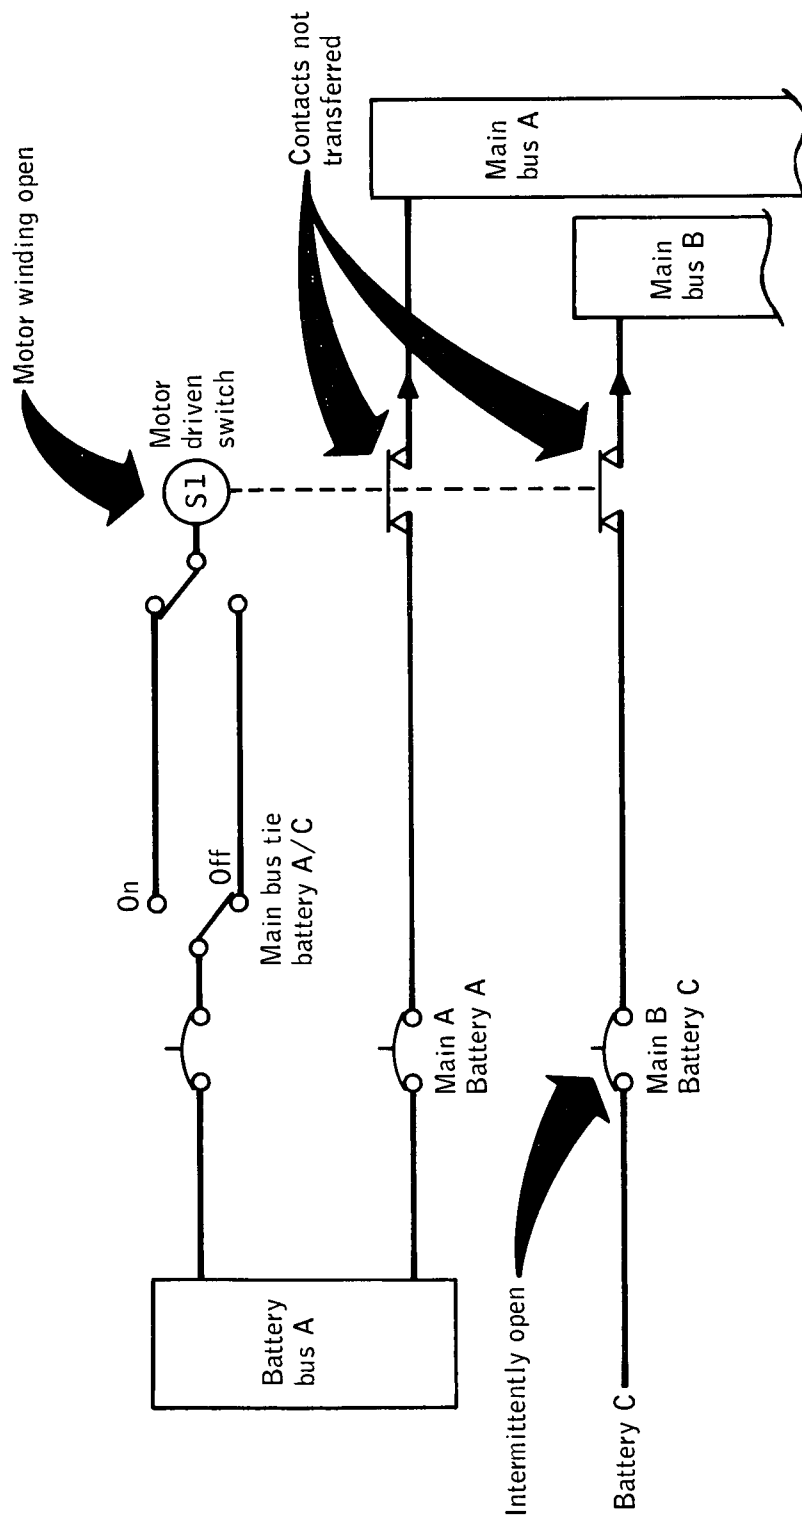
Figure 1.- Bus-tie circuitry.

During Apollo 14 entry, at 800 feet altitude, the switches for disconnecting battery busses from the main busses were placed to "off". Although both main busses should have been de-energized by this action, main A remained energized until it was manually disabled by opening the associated circuit breakers after landing.

A preliminary evaluation indicated that motor switch S1 had failed to transfer to "off" (fig. 1). Postflight testing verified this condition; however, had this been the only failure, both main busses would have remained energized until the circuit breakers were opened. Additional spacecraft testing disclosed an intermittent condition within the battery C-to-main bus B circuit (fig. 1). The circuit breaker which connects battery C to main bus B could be closed mechanically by applying nine pounds of pressure to the actuator knob, but an additional three pounds was required to maintain circuit continuity. The condition was repeatable on the bench, and X-rays showed one set of contacts were being held apart by an unidentified substance. Disassembly and microscopic examination of the breaker showed the contacts to be cratered (fig. 2) and partially covered with a sufficient quantity of white crystalline substance to separate the contacts. Chemical analysis of particles removed from the circuit breaker showed both molydisulfide (dry lube) and glass were present.

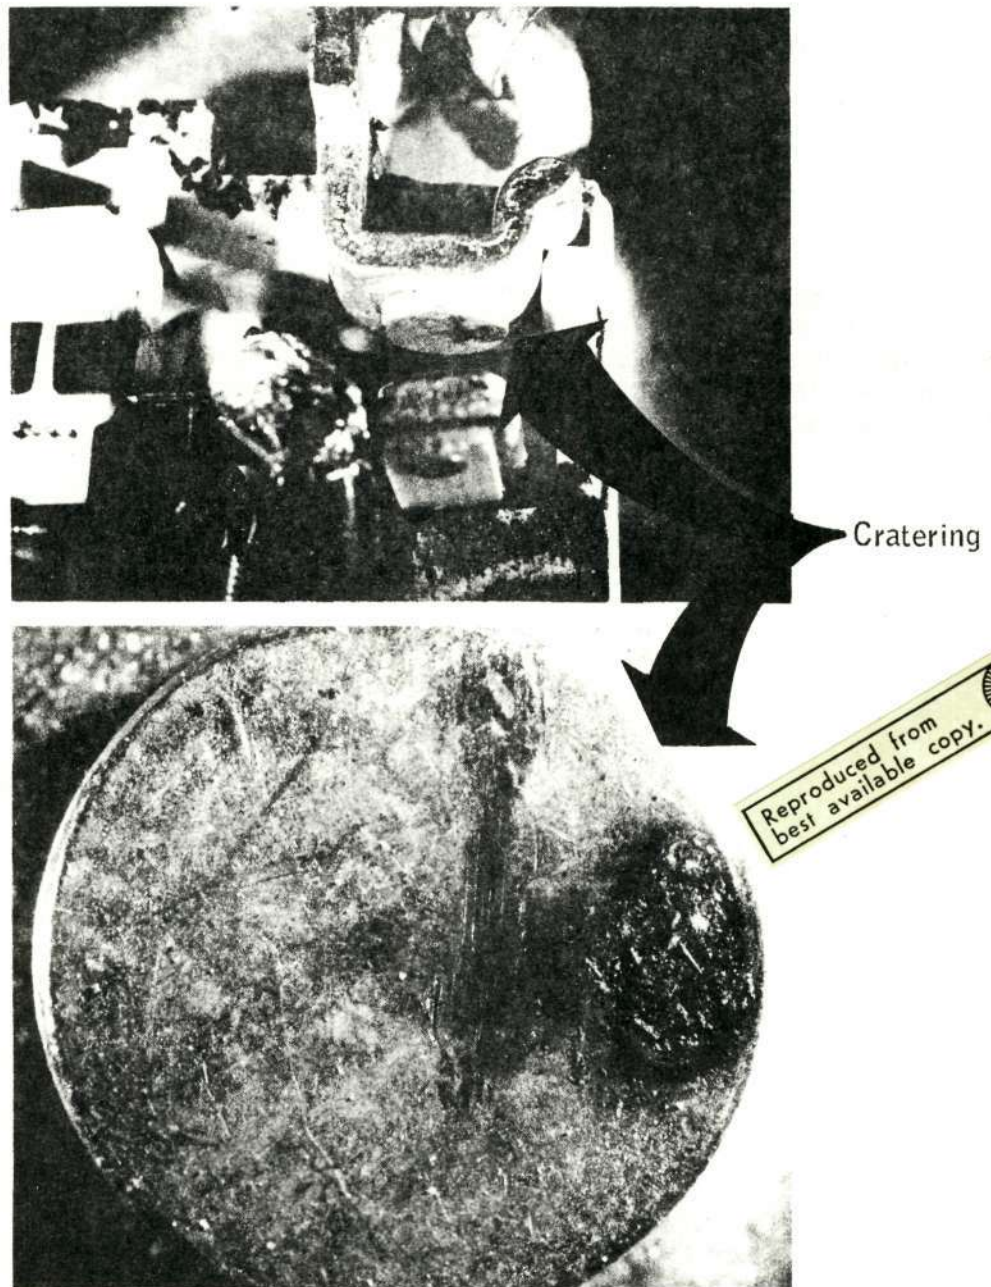
One component inside the breaker was made of fiberglass which provides a source of glass particles. Glass particles could have become separated from the component, and could have been responsible for the failure.

Figure 2.- Circuit breaker contact with cratering.

Continuity through the circuit breaker in the mechanically closed condition was prevented by a foreign substance, most probably glass particles, on the contact surface. Since this was the only failure of this type in over 3400 units that have been flown and since no circuit breaker is a single-point failure for crew safety or mission success, no corrective action is deemed necessary.
